EXHIBIT K

Materials Characterization of Explanted Polypropylene Hernia Meshes

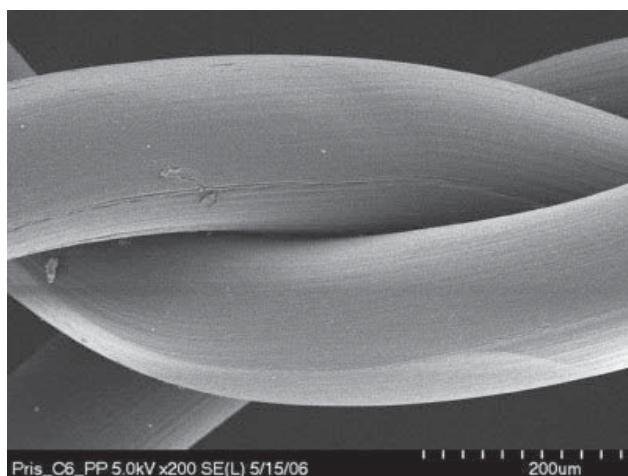
As shown in Figure 4, SEM micrographs of the polypropylene component of a pristine Composix E/X mesh revealed smooth fibers without any evidence of surface degradation

Figure 4. SEM of the polypropylene component of a pristine Composix E/X mesh.

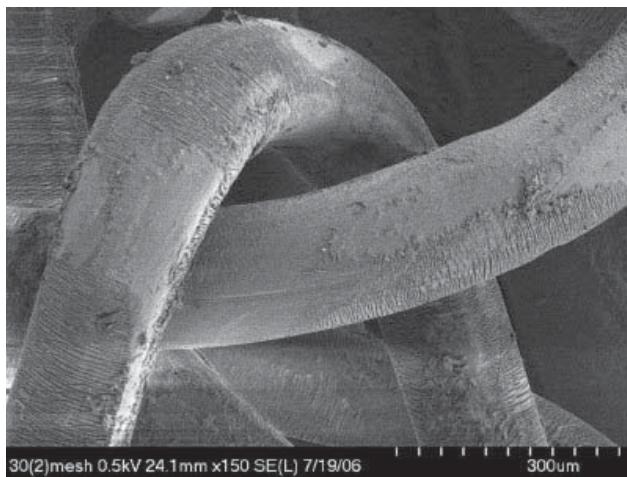
Figure 5. SEM of an explanted polypropylene mesh with transverse cracks.

such as cracks or fissures. Conversely, as shown in Figures 5–7, the explanted polypropylene specimens appeared badly degraded, including cracks, fissures, and increased surface roughness. Micrographs of 79% of all explanted specimens exhibited cracks in the transverse or longitudinal direction, 57% showed what appeared as a peeling of the fiber surface, and 64% displayed a rough, blistered surface. Overall, 85% of the explanted specimens possessed at least two or more of these types of surface structures.

The SEM micrographs displayed images of materials that were vastly different in topology than the pristine materials. The micrographs of explanted polypropylene materials exhibited cracks, surface roughness, and peeling indicative of surface degradation,^{6,10,12} while the pristine materials appeared smooth.

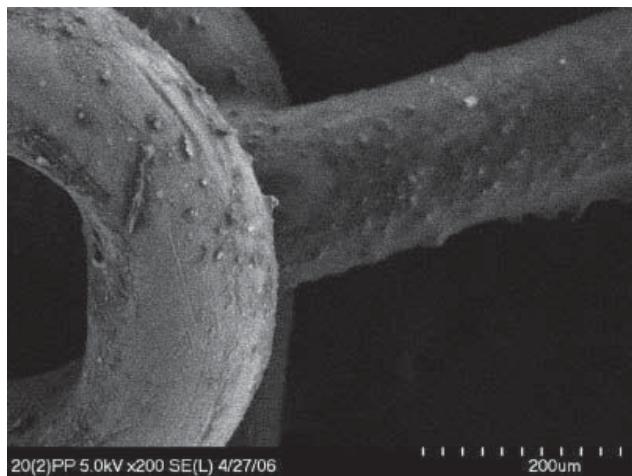
Figure 6. SEM of an explanted polypropylene mesh with blisters on the fibers.

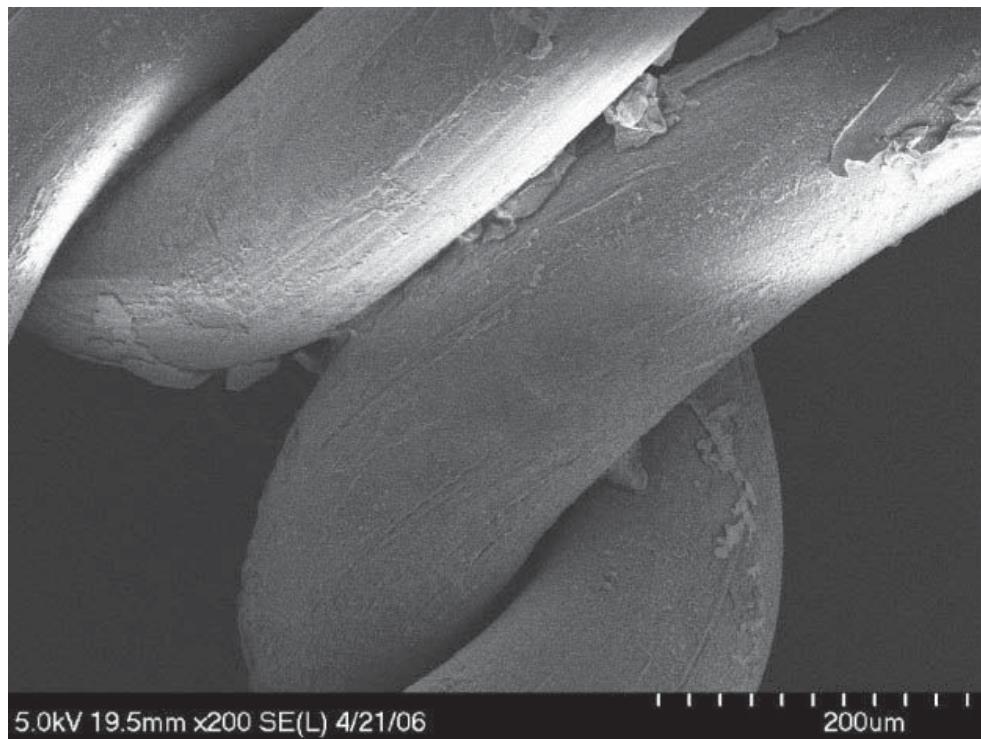
Figure 7. SEM of an explanted polypropylene mesh with “peeling” fibers.

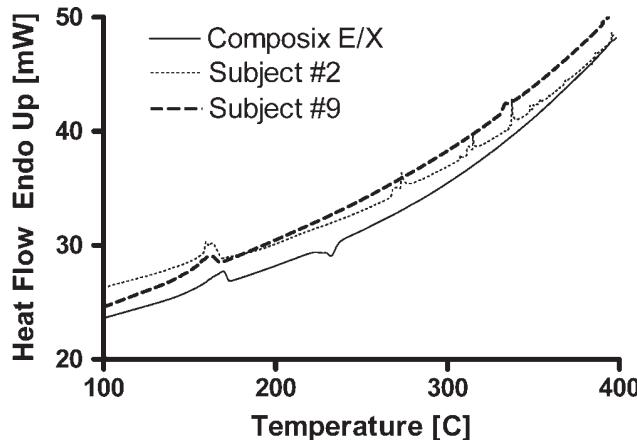
Figure 8 depicts the results of DSC for two explanted specimens versus the pristine polypropylene specimen. Although this graph depicts only two explanted specimens, it is representative of the results obtained for all 14 explants. All explants displayed a lower melting temperature of approximately 163°C on average as compared to 166°C for the pristine, with five of the 14 explants having a *p*-value < 0.05. Half of the explants exhibited broader melting peaks, and the majority possessed a smaller area under the curve.

DSC results displayed melting temperatures and heat of fusion in explanted materials that were lower than the pristine values. The melting peak of the explanted materials was also broader; most likely due to increased polydispersity of the material. The majority of the explanted polypropylene mesh samples displayed a change from the pristine for all three of these effects, indicating that oxidation of the material may have occurred while *in vivo*; however, not all of these effects were considered statistically significant. The lack of statistical significance for all the samples may be due to the shorter implantation times experienced by some of the explants.

Figure 8. DSC thermograms of explanted and pristine specimens.

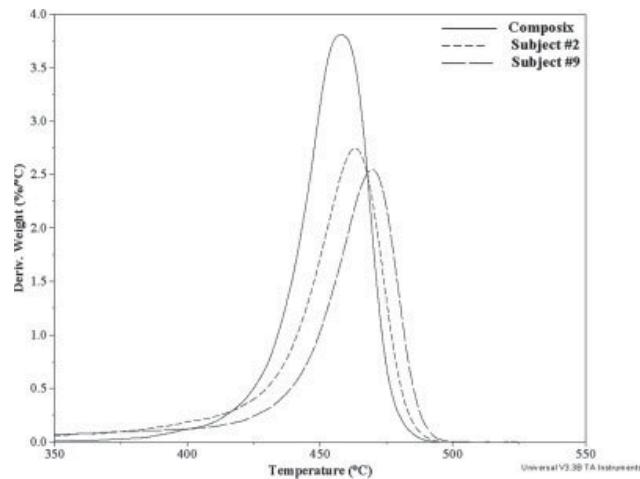
After TGA, each thermogram was integrated to obtain the area under the curve. This provided a quantitative analysis of the entire thermal event of each explant, rather than just an analysis of the conditions at the peak temperature. Figure 9 depicts the resulting thermograms for two explanted specimens versus the pristine polypropylene specimen. All explanted specimens exhibited a shift in the peak temperature from 458°C for pristine materials to a higher temperature of approximately 465°C on average for the explanted meshes. The majority of the explants had a *p*-value < 0.05, and nearly all displayed a smaller mean area under the curve of 9.67% versus 12.04% for pristine materials.

Oxidized materials are expected to undergo some degree of weight loss as the material is degraded by the body.^{10,12} Thus oxidized materials should have less weight available to be lost during TGA. Weight loss during TGA is reflected in the area under the curve, and so oxidized materials should display less area under the curve. As expected, the majority of the explanted polypropylene specimens showed significantly less weight loss during TGA as compared to the pristine Composix E/X specimen, further strengthening the argument that these materials underwent oxidation *in vivo*.

Figure 9. TGA thermograms of explanted and pristine specimens.

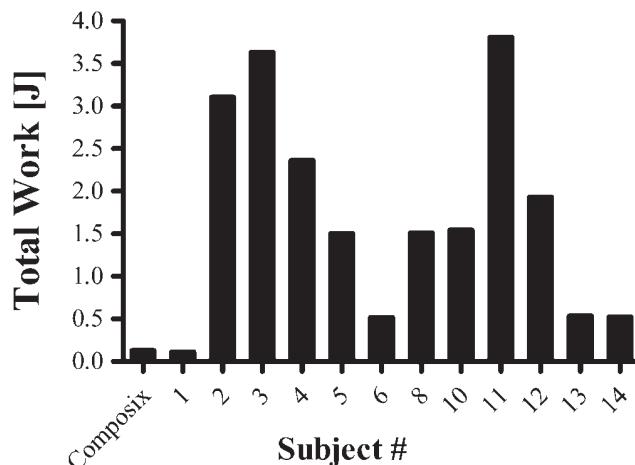
The mean value for the total work required to fold each mesh in half and push it through the slot is shown in Figure 10. Nearly all explanted materials required more work than the pristine Composix E/X mesh, with values ranging from 4 times the work required for a pristine mesh to nearly 30 times this value, indicating an overall decrease in the compliance of these materials.

The results of the compliance test on explanted polypropylene materials indicate reduced compliance in all but one explant, which is evidence of oxidation^{11,13} as well as a potential explanation for decreased abdominal wall function and chronic pain. Welty et al. examined patients using 3D stereography to measure the stiffness of the abdominal wall following hernia repair with a polypropylene mesh material. The results of this study indicated that patients complained of paresthesia 4–58% of the time, depending on the “weight” (g/m^2) of the polypropylene material and had

Figure 10. Total work required for compliance testing of explanted and pristine specimens.
